PIC32MK General Purpose and Motor Control (GP/MC) Silicon Errata and Data Sheet Clarification

The PIC32MK General Purpose and Motor Control (GP/MC) family of devices that you have received conform functionally to the current Device Data Sheet (DS60001402F), except for the anomalies described in this document.

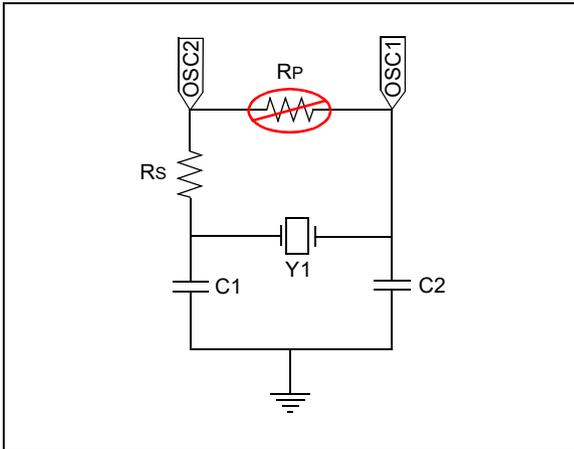
FIGURE 1: Posc CRYSTAL CIRCUIT

The Posc supports only specific crystal operation, as provided in [Table 1](#).

The Primary Oscillator (Posc) has been characterized to operate at 8 MHz and 12 MHz when the circuit shown in [Figure 1](#) is implemented and the operating conditions provided in [Table 1](#) are met.

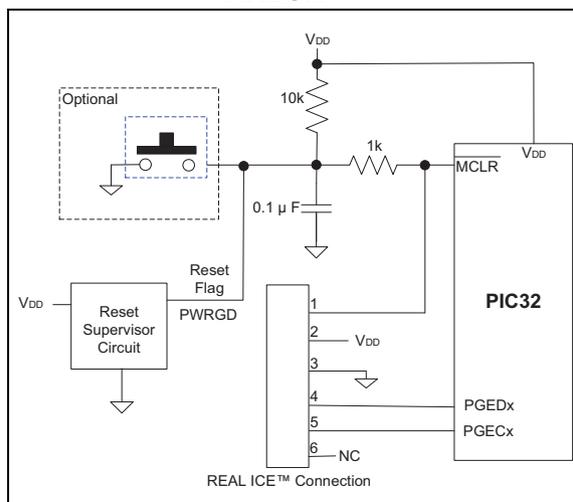
FIGURE 2: RESET SUPERVISOR CIRCUIT

On a BOR event, $V_{POR} < V_{DD} < V_{BOR}$, a Reset is not generated when the BOR threshold is reached. System clocks will stop with all I/O pins functions frozen in their present state until either V_{DD} falls to V_{POR} or V_{DD} returns to above V_{BOR} . The user must assess if this V_{DD} brown-out condition and the resulting frozen I/O pin state has an adverse effect on their application (UART, PWM, I/O, OC, etc.).

If the application can sustain frozen I/O states for ~2.1 ms (UART, CAN, I/O, etc.), the application must enable the Deep Sleep Watchdog Timer and Clock Fail Monitor, based on the details provided in Table 3 and Table 4. If implemented correctly, after ~2.1 ms, a valid internal reset state is entered and the I/O pins are set to the device default Reset state.
